TECHNICAL SERVICE REPORT

OWNER: Equipment Test **INTERNATIONAL REP:** P. Bock;
Attn: Mr. Kristian Dalseide **DATE:** 10/07/2003
APPLICATOR: International Paint Company Houston TX test lab
EQUIPT. DESCR: Carbon Steel Piping, previously coated with Epoxy
LOC: International Paint Company Houston TX spray test lab
SURFACE PREP: "Rustibus" surface preparation machine for straight-run piping
COATING SYSTEM: Interseal 670HS Surface Tolerant Epoxy

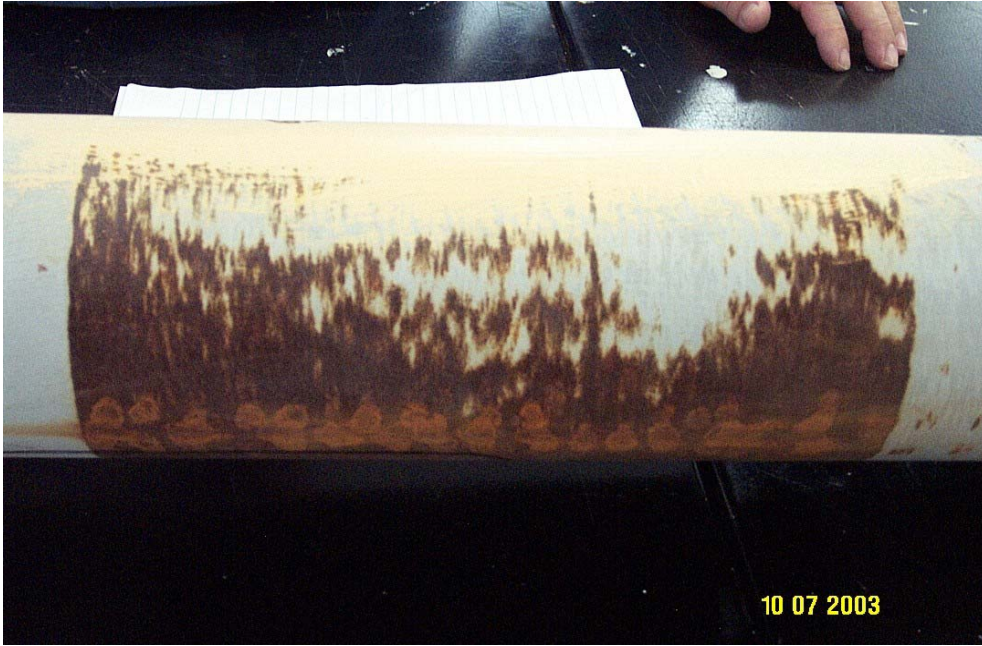
Photos "Rustibus" B, C and D show the pipe area tested and the pulled dollies. For comparison, Photo A shows an uncoated area of pipe, which had been partly prepared with the "Rustibus" machine. The surface preparation texture and striation are clearly visible. On areas coated for the test, all old (light gray) epoxy was removed to bare steel before application of the buff Interseal 670HS.

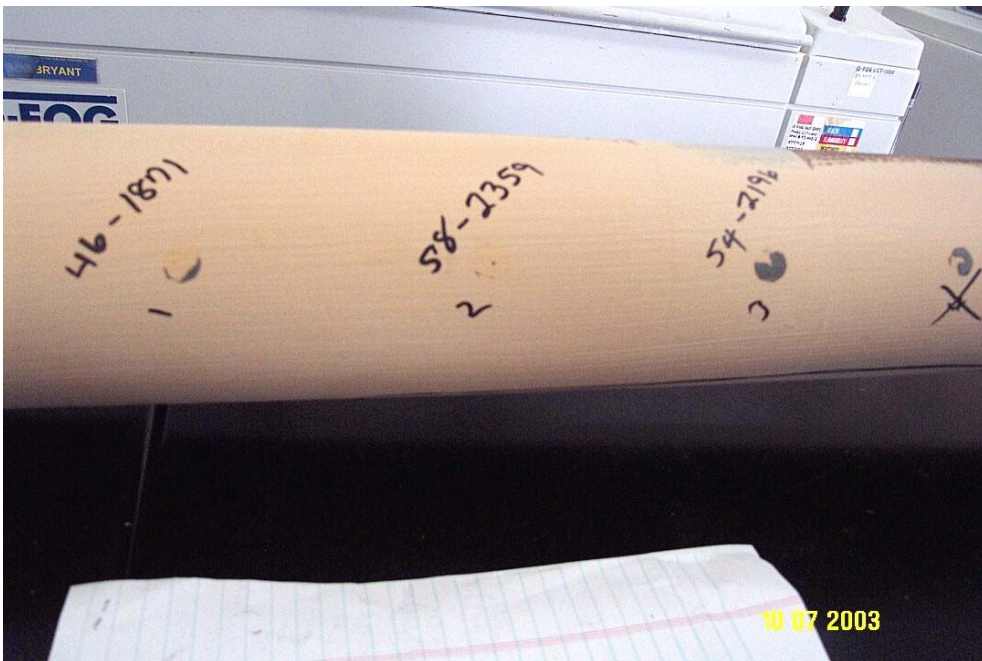
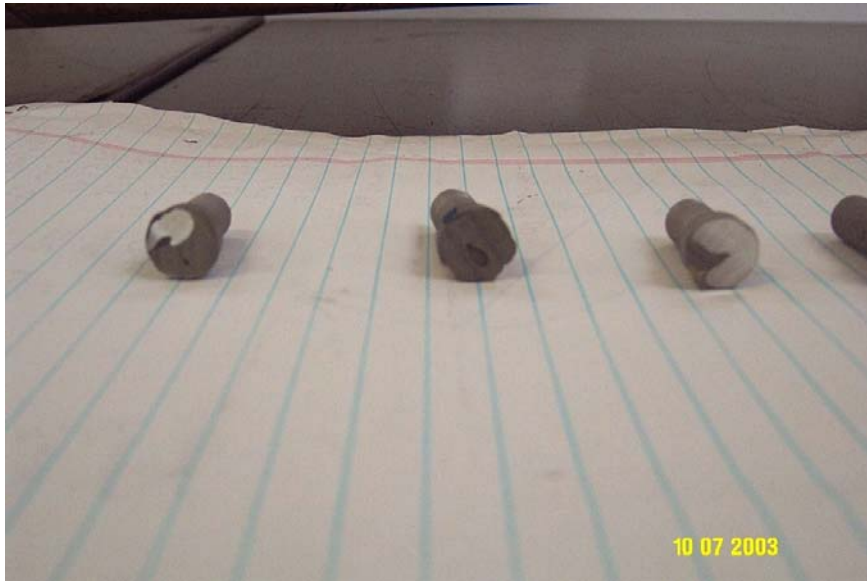
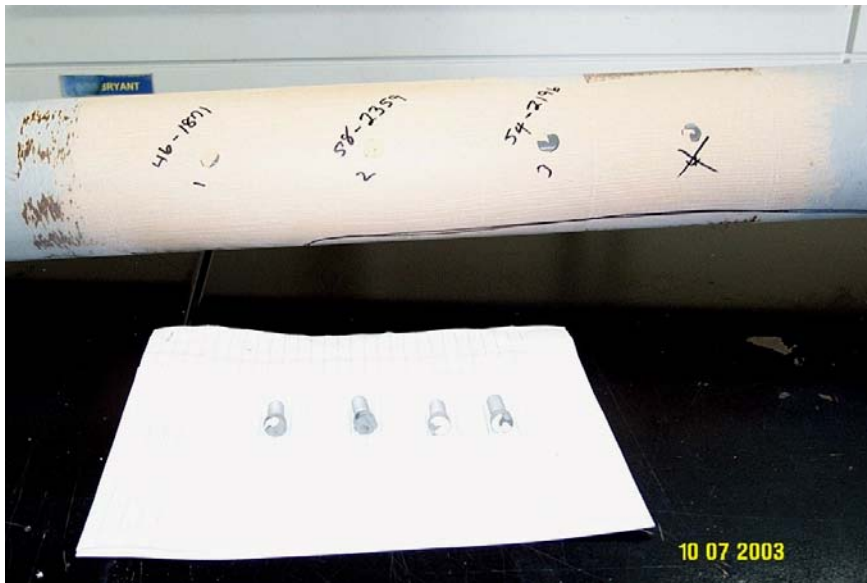
Dolly 1:	1871 lbs	Part Glue Failure, part midcoat cohesion failure
Dolly 2:	2359 lbs	Glue Failure
Dolly 3:	2196 lbs	Part Glue Failure, part midcoat cohesion failure
Dolly 4:	Mis-pull,	no reading registered

Based on this test, International Paint Company recommends use of the "Rustibus" surface preparation machine for straight-run piping where the resulting level of surface preparation is acceptable to the owner or specification writer, and where the prepared surface is to be overcoated with Interseal 670HS or a similar surface tolerant epoxy. The "Rustibus" surface preparation machine performs as advertised by its manufacturer.
